PROOF DEPARTMENT  
ARMY AIR FORCES PROVING GROUND COMMAND  
EGLIN FIELD, FLORIDA

FINAL REPORT

TEST OF T14 FIELD MECHANISMS FOR 20MM GUN AN-M2

Serial No.: 2-43-91 No. of Pages: 5 Date: 23 November 1943  
AAF Board Project No. (M-5) 23

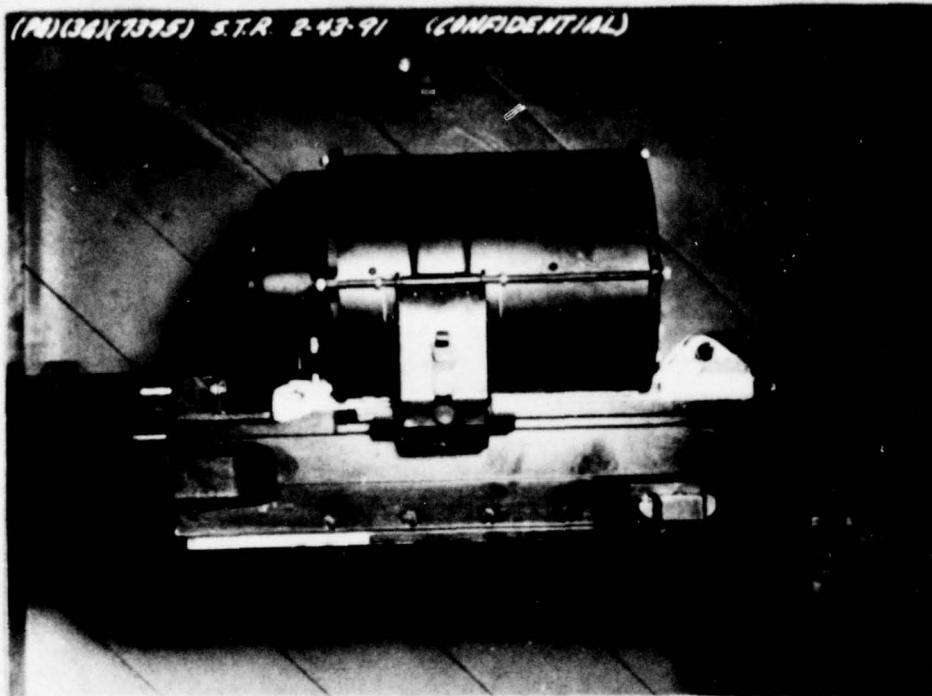
(P)(36)(7395) S.T.R. 2-43-91 (CONFIDENTIAL)

Side view of  
Standard AN-M1  
feeder.

These two (2) photo-  
graphs show the con-  
trast in size of the  
AN-M1 and T-14  
feeders.

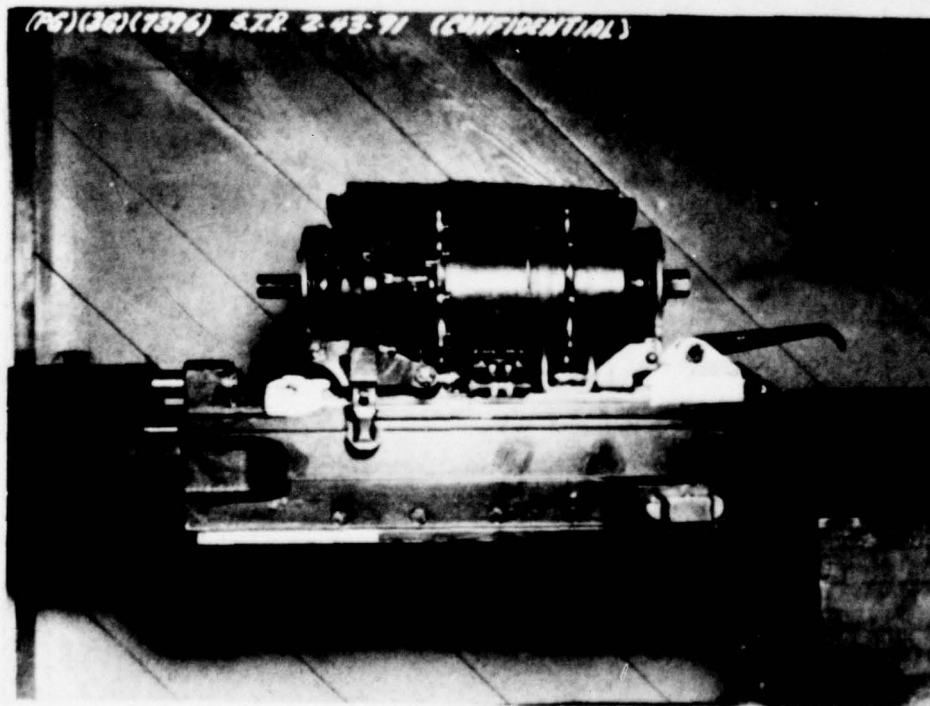
(P)(36)(7396) S.T.R. 2-43-91 (CONFIDENTIAL)

b. Less time is required to train personnel properly to maintain the TL4 feed mechanisms for 20mm cannon than is required for the AN-M1 feeders. The TL4 feeders are open and expose all of the operating parts; breakages can be seen easily without taking the feeder apart. This type feeder will require less maintenance in actual field conditions. No oiling is necessary and the parts do not burr as easily as in the AN-M1 feeders. Burrs often make it necessary to take the AN-M1 feeders apart and stone the burred parts. The TL4 feed is more easily and quickly taken apart and reassembled than the AN-M1 feeder. It is not necessary to take the TL4 feeder apart as often as the AN-M1 feeder. The TL4 feeders are smaller and easier to install. (See Inclosures 7 and 8.)

Side view of T-14  
feeder.

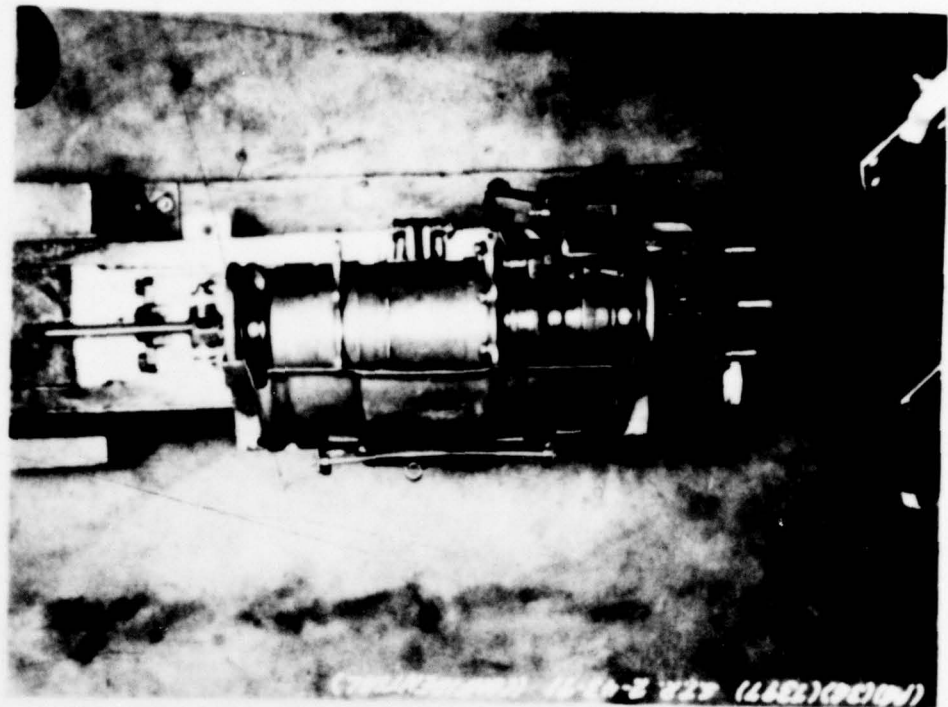
Inlosure 8.

Top view of T-14 feeder.

These two (2) photo-  
graphs show the contrast  
in size of the AN-M1  
and T-14 feeders.
